Phase II Environmental Site Assessment

**Former Richmond Creamery
Richmond, Vermont
VT DEC SMS#2008-3835**

April 19, 2010

Re: Phase II Environmental Site Assessment
Former Richmond Creamery
Richmond, Vermont
JCO Project #1-0346-3

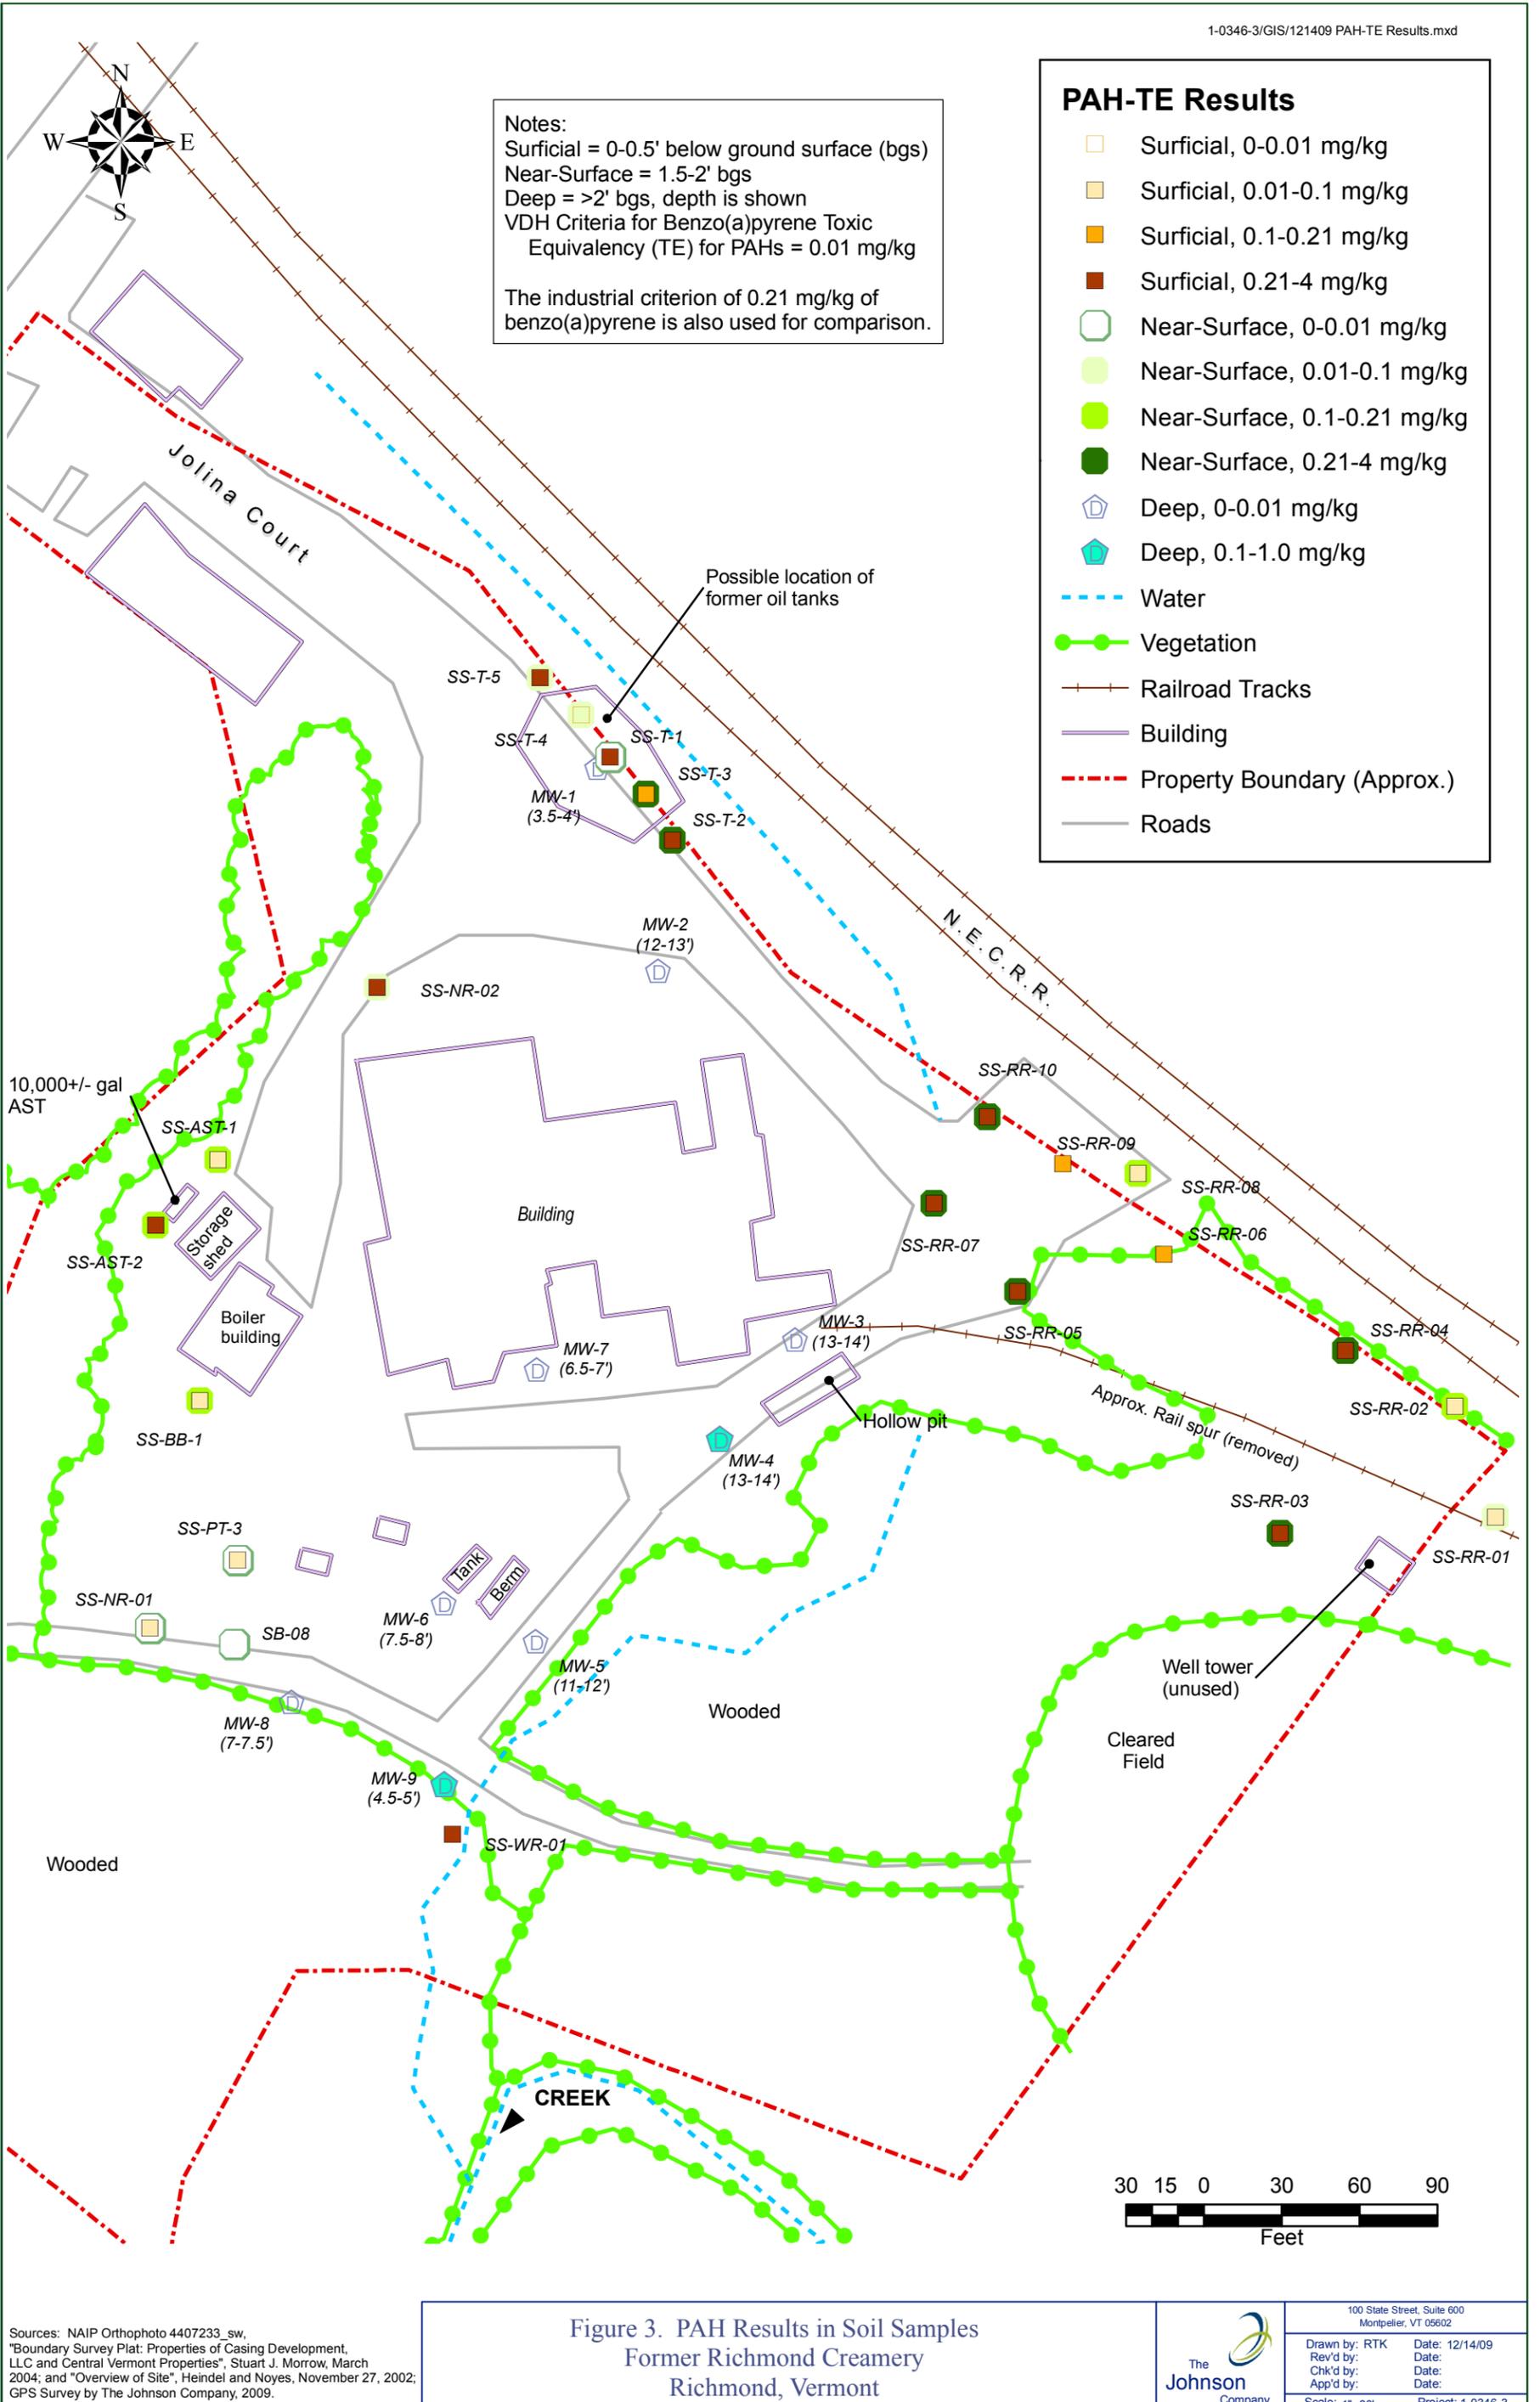
Figure 3. PAH Results in Soil Samples
 Former Richmond Creamery
 Richmond, Vermont

The SVOC soil laboratory results are summarized in Table 12, and PAH results are summarized in Table 7. Several PAH compounds were detected above laboratory reporting limits. The VDH screening level for carcinogenic PAH compounds requires calculation of the total equivalent (TE) risk caused by all of these PAHs for comparison against a value expressed as the benzo(a)pyrene criterion. For these calculations, each carcinogenic PAH is assigned a toxic equivalent factor (TEF) that indicates how toxic the compound is compared to benzo(a)pyrene (i.e., benzo(a)pyrene has a TEF of 1, whereas chrysene is considered less toxic and has a TEF of 0.001). These calculations are summarized in Table 8, and the results are shown on Figure 3. The results were compared to the VDH benzo(a)pyrene-TE criterion of 0.01 mg/kg. The VDH benzo(a)pyrene-TE screening value was exceeded in all samples where PAHs were reported in exceedance of laboratory detection limits, including all surface (0-0.5 foot depth) soil sampling results. The VDH benzo(a)pyrene-TE screening value was not exceeded in near surface (1.5-2.0 foot depth) samples collected at SS-NR-01, SB-08, SS-T-1, SS-T-2 and SS-PT-3. The SS-RR-03 and 05 samples were collected from locations to the south of the former

rail spur in currently wooded areas, and may indicate a release of coal or other burned materials. The two non-railroad surficial soil samples at SS-NR-01 and 02 contained carcinogenic PAHs that exceeded the benzo(a)pyrene-TE criterion, with the lowest TE at SS-NR-01 (0.05 mg/kg), and a somewhat higher value of 0.36 mg/kg at SS-NR-02.

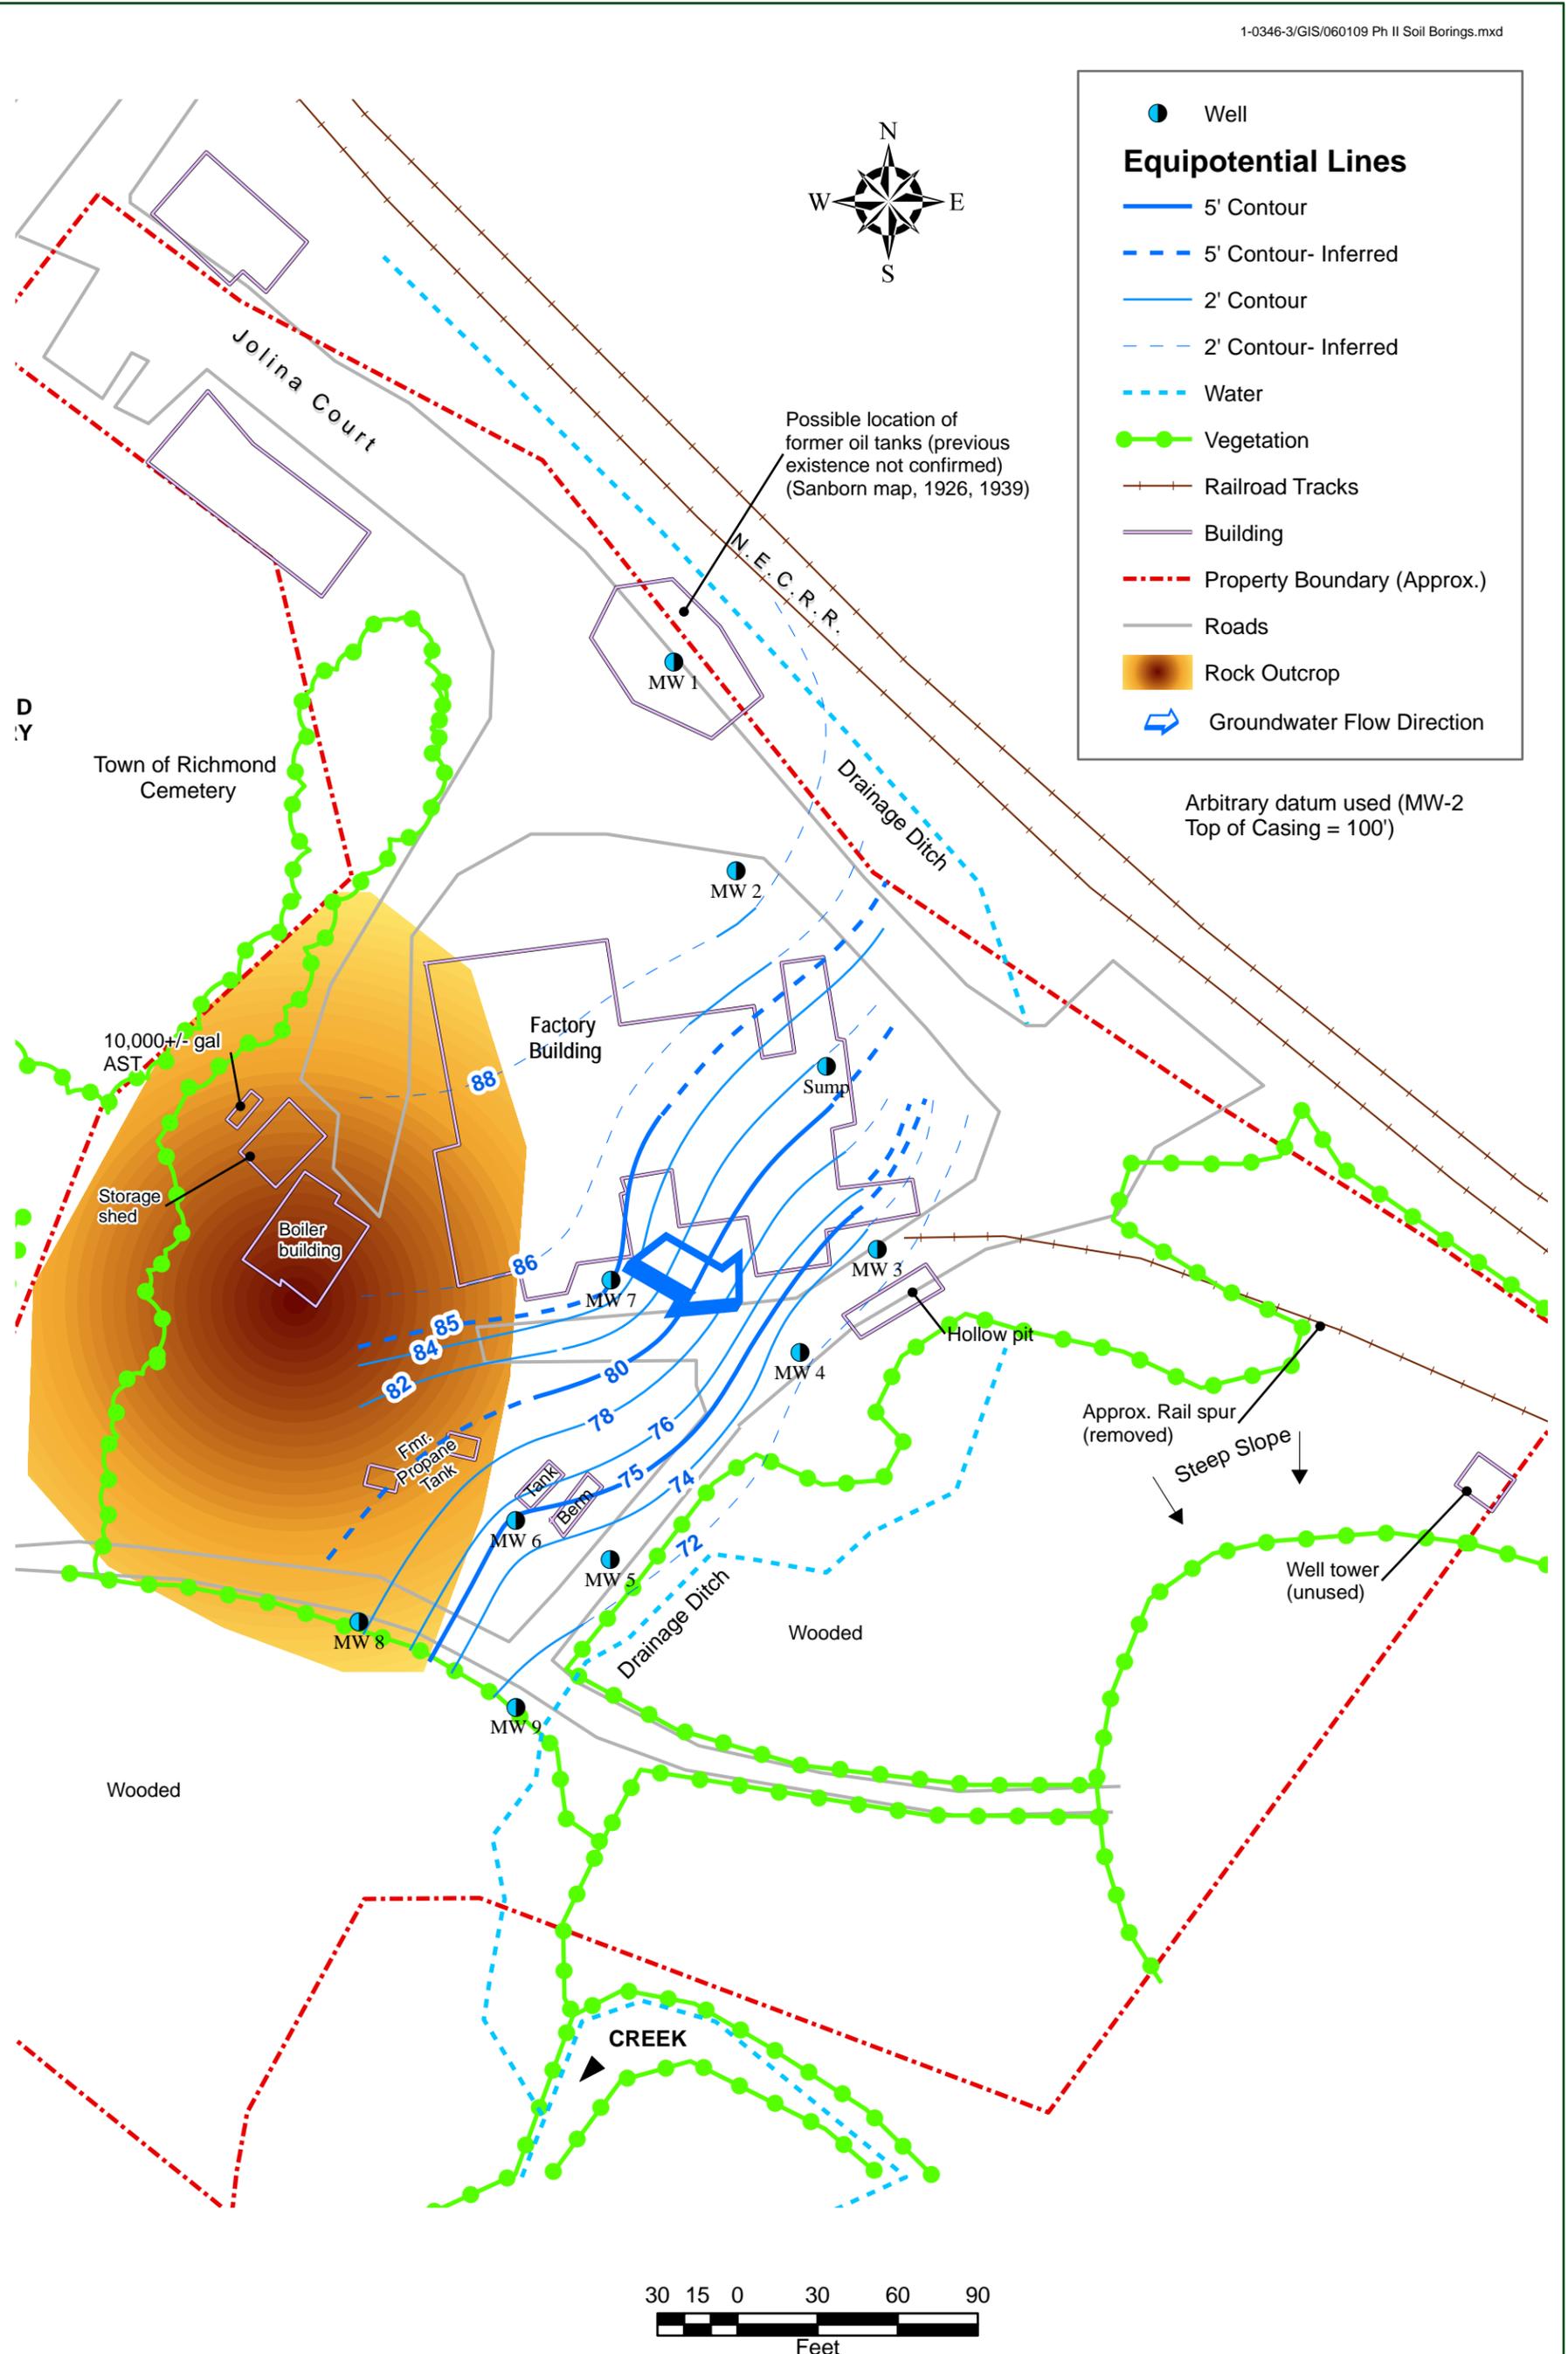
Figure 5. Groundwater Equipotential Map
Former Richmond Creamery
Richmond, Vermont

Arbitrary datum used (MW-2 Top of Casing = 100')

Possible location of former oil tanks (previous existence not confirmed) (Sanborn map, 1926, 1939)

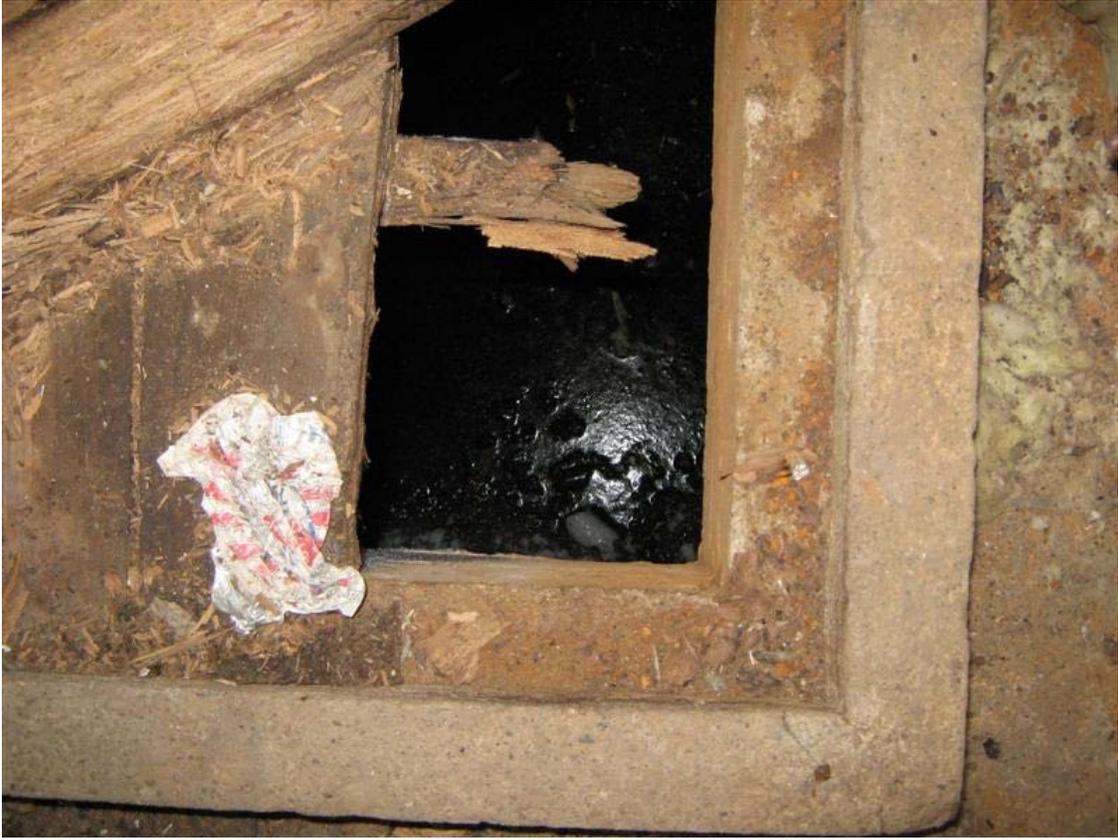
Plate 3: Sump

A concrete structure with a considerable quantity of water, possibly a sump, was observed in the ammonia compressor room. Photos of the aqueous sump contents are included in Appendix 1. The depth to the top of the water was approximately 4.5 feet below the top of the concrete structure, which is raised approximately 1.5 feet above the floor surface. A peristaltic pump was used to sample the aqueous contents of the sump, and samples were submitted for volatile organic compounds (VOCs) via EPA Method 8260, semi-volatile organic compounds

- Concentrations of arsenic were observed above VGES in a sump located in the factory building. Metals concentrations were consistent with surrounding shallow groundwater, and no remedial actions are recommended. However, exposure to the water in the sump should be prevented during redevelopment activities by removing the sump. Alternatively, since the sump may be connected to groundwater and it may not be possible to completely pump out, the sump could also be covered to secure access and prevent ingestion of the water.

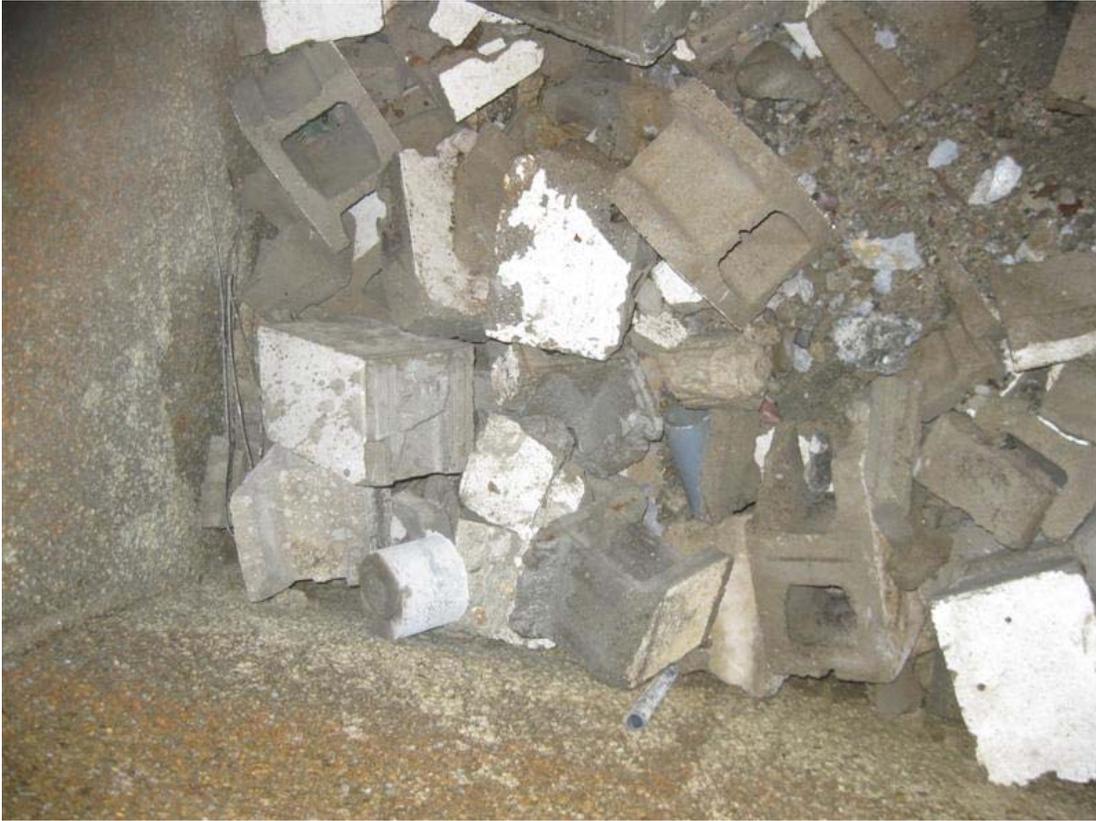
Plate 5: Concrete Rubble Contents of Pit

An excavator was used to uncover the soil above the pit and penetrate the concrete cover on March 23, 2009. The contents of the pit were observed to be concrete rubble. Photos of the pit contents are included in Appendix 1. To confirm the pit did not contain water or soil, a concrete corer was used to core a four inch hole at an additional location of the concrete pit cover on March 24, 2009. The depth to the top of rubble in the pit was measured at approximately 6 feet. An extendable hand auger was inserted into the cored hole, and no sample was retrieved. After further inspection, it was confirmed that the bottom of the pit at both locations was covered with concrete rubble. A Photoionization Detector (PID) was lowered into the pit and only trace

readings (0.2 PPM) were observed. The historical contents of the tank are unknown, but no visual or olfactory evidence of petroleum products or chemical storage were observed. Because the installation of wells downgradient of the pit were dependent on sampling results but no sampling results could be obtained, two wells were installed in a presumed downgradient direction of the pit to the south (See Section 2.10 – Groundwater Quality Investigation).

- A hollow pit of concrete rubble does not appear to be impacting groundwater or soil and no remedial actions are recommended to address the pit. However, this pit could pose a safety hazard for future redevelopment activities and should be managed appropriately.

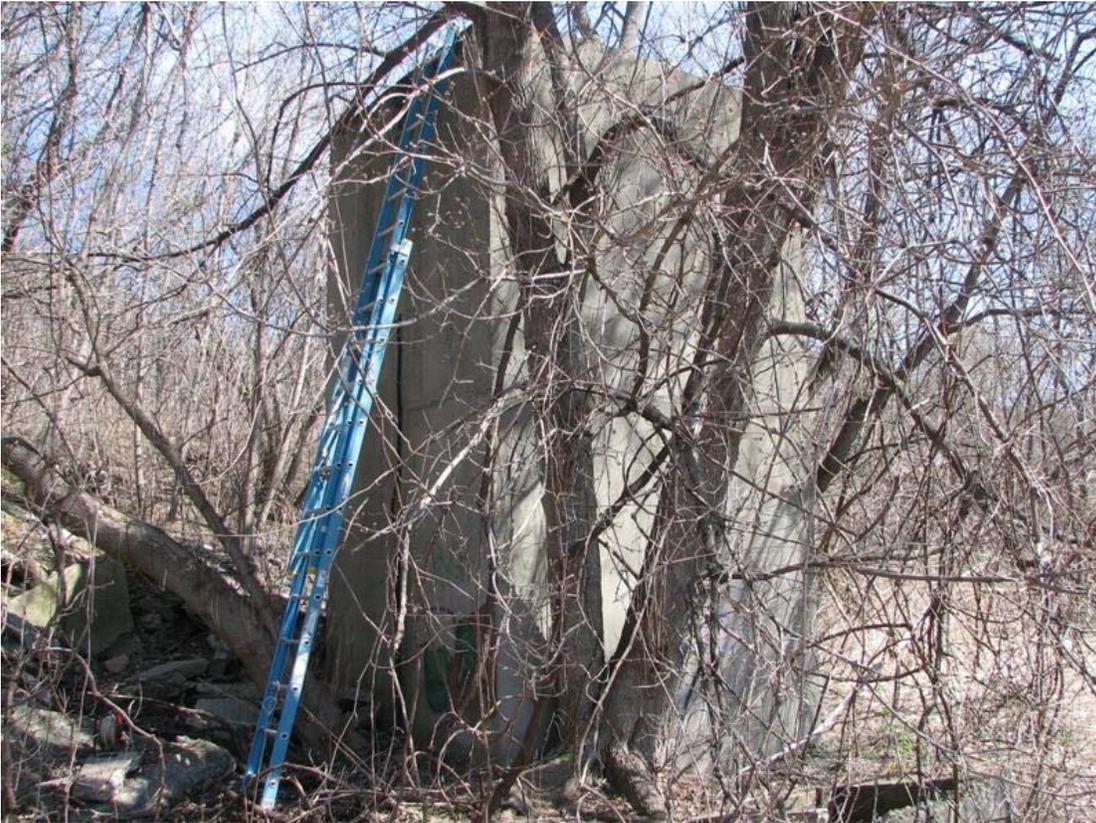
Plate 6: Well Tower

- Water supply well, not abandoned or used since connection to Town of Richmond municipal water supply. If unsecured, this well can provide a conduit for hazardous materials to be released to groundwater.

An attempt was made to access the existing onsite water supply well on April 14, 2009. The water supply well is enclosed in a concrete structure, approximately 20 feet high, which has no ladders, doors, or other forms of direct access on the sides. It is suspected that there may have been a bridge or platform from the level of the former rail spur located to the north of the tower, but none exists now. The well could not be safely accessed from the top of the structure. There is a platform at the top of the tower, and a steel ladder descends into the structure. Since the condition of the interior ladder could not be verified and the opening was relatively small, the interior of the tower was deemed to be a confined space and was not entered by The Johnson Company staff. A water level indicator was lowered into the opening, but it indicated that access to the well was blocked from within the concrete structure at approximately ground level. Photographs of the well tower are included in Appendix 1.

- No remedial actions are recommended for groundwater unless a use is identified for the existing water supply well, in which case additional sampling should be conducted in advance of use. No additional water supply wells should be installed on the property without advance coordination with the Sites Management Section of VT DEC.

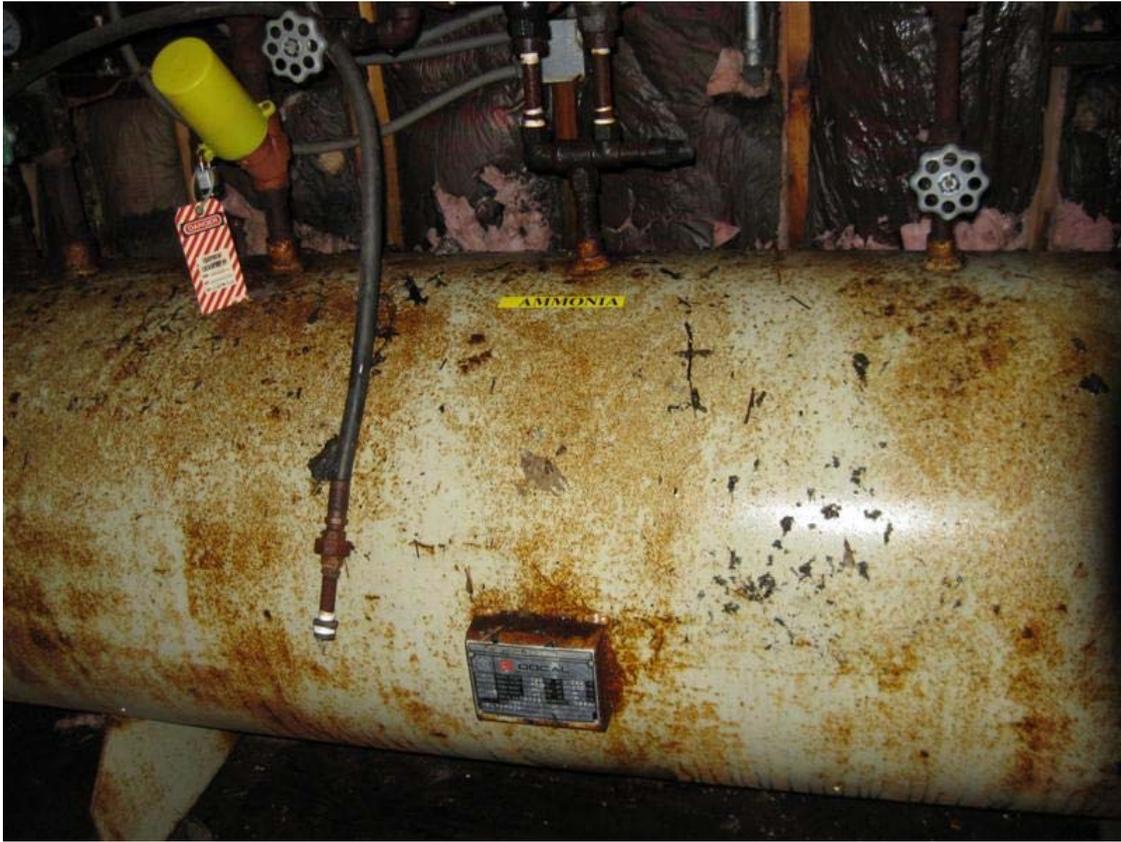
Plate 9: Ammonia Tank

A licensed refrigeration contractor conducted a Site visit on April 14, 2009 to inspect the status of the ammonia refrigeration system. Governed Air of Vermont, Inc. of South Burlington, Vermont concluded that ammonia was still present in significant quantities in the ammonia tank (an approximately 250 gallon tank was observed to be about ½ full). Since the ammonia is contained inside the building, a release could be expected to volatilize quickly and not present a risk to soil or groundwater; however, such a release would pose a significant health and safety hazard to workers or visitors to the Site. A photo of the ammonia tank is included in Appendix 1.

- The presence of ammonia was confirmed in the abandoned refrigeration system. In its current condition, the ammonia refrigeration system does not pose an environmental hazard. However, it could pose a health and safety risk for future redevelopment activities. Ammonia in the storage tank should be pumped and reclaimed, and any residual ammonia present in refrigeration system removed prior to demolition or reuse of the building.

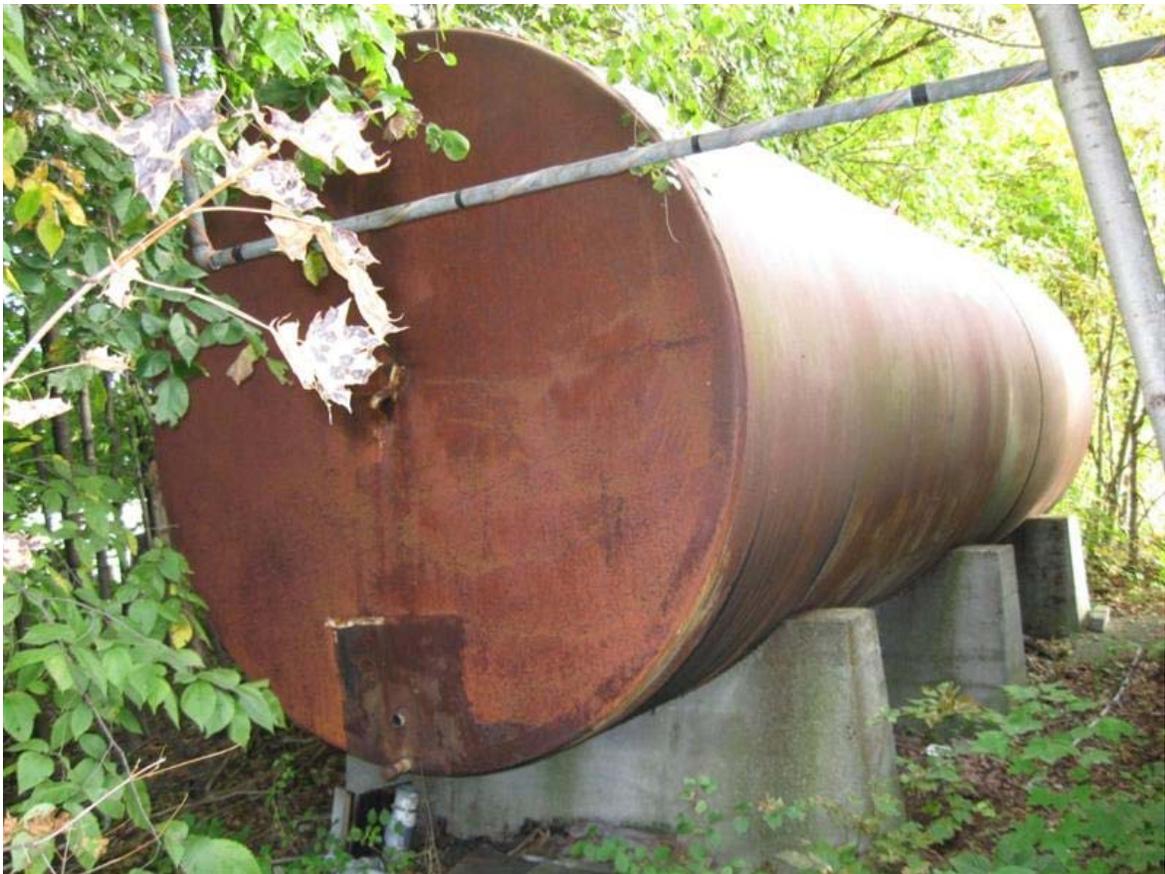
Plate 10: Above Ground Storage Tank

- A 10,000-gallon above ground storage tank (AST) containing some residual fuel oil sludge is present on the Site. The piping for this AST was routed overhead, and no staining or olfactory evidence of releases to the ground surface were observed.
- Residual ammonia potentially present in the abandoned refrigeration system.
- Asbestos was previously identified in the shingles that cover the outside of the factory building; asbestos may also be present in building materials in the factory building and in soils.
- Lead may be present in soils and paint on the factory building.
- Pesticides may be present in soils on the Site due to the proximity to cleared cropland.
